THE TSUNAMI

Alaskan Earthquake, 1964 : Engineering Evaluation

TECHNICAL MEMORANDUM NO. 25

COASTAL ENGINEERING RESEARCH CENTER

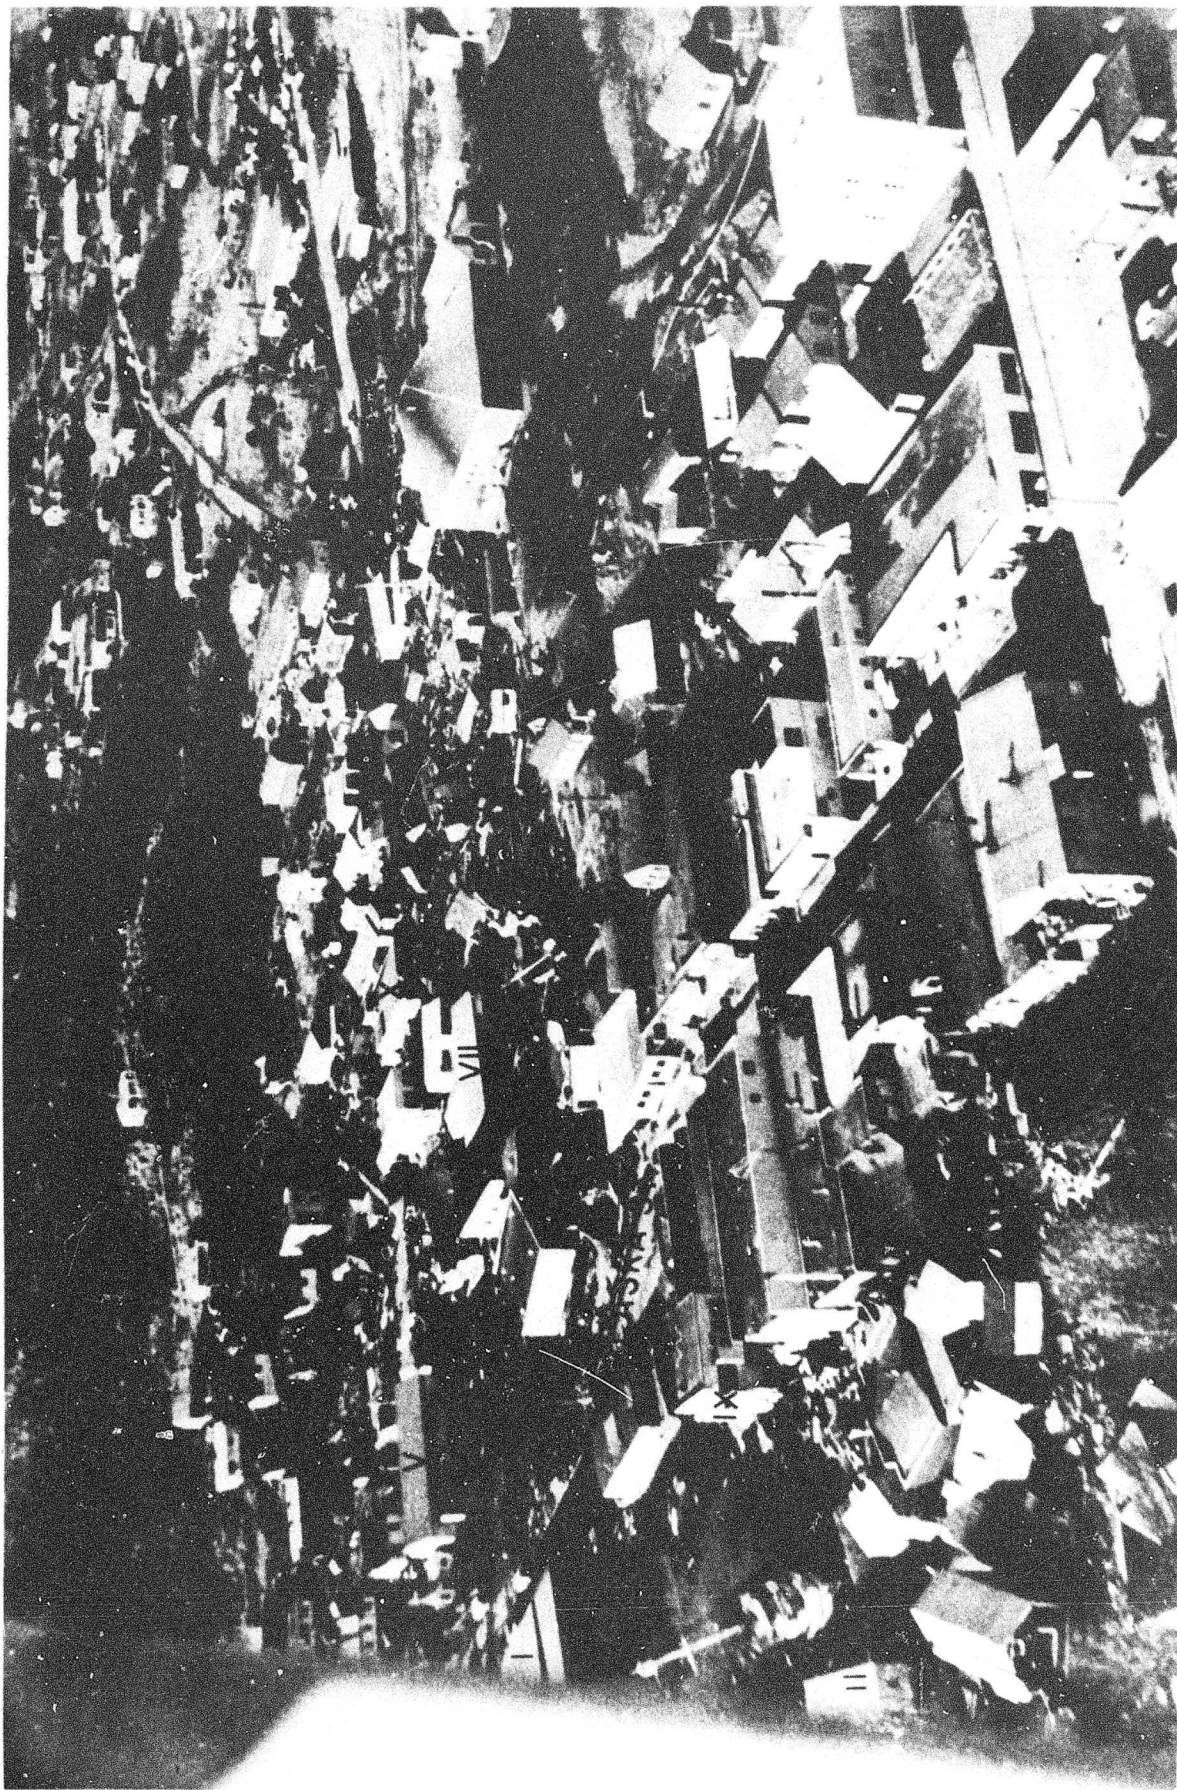
Figure 104 Tsunami Damage in Downtown Kodiak. (Photograph by Alf Madsen)

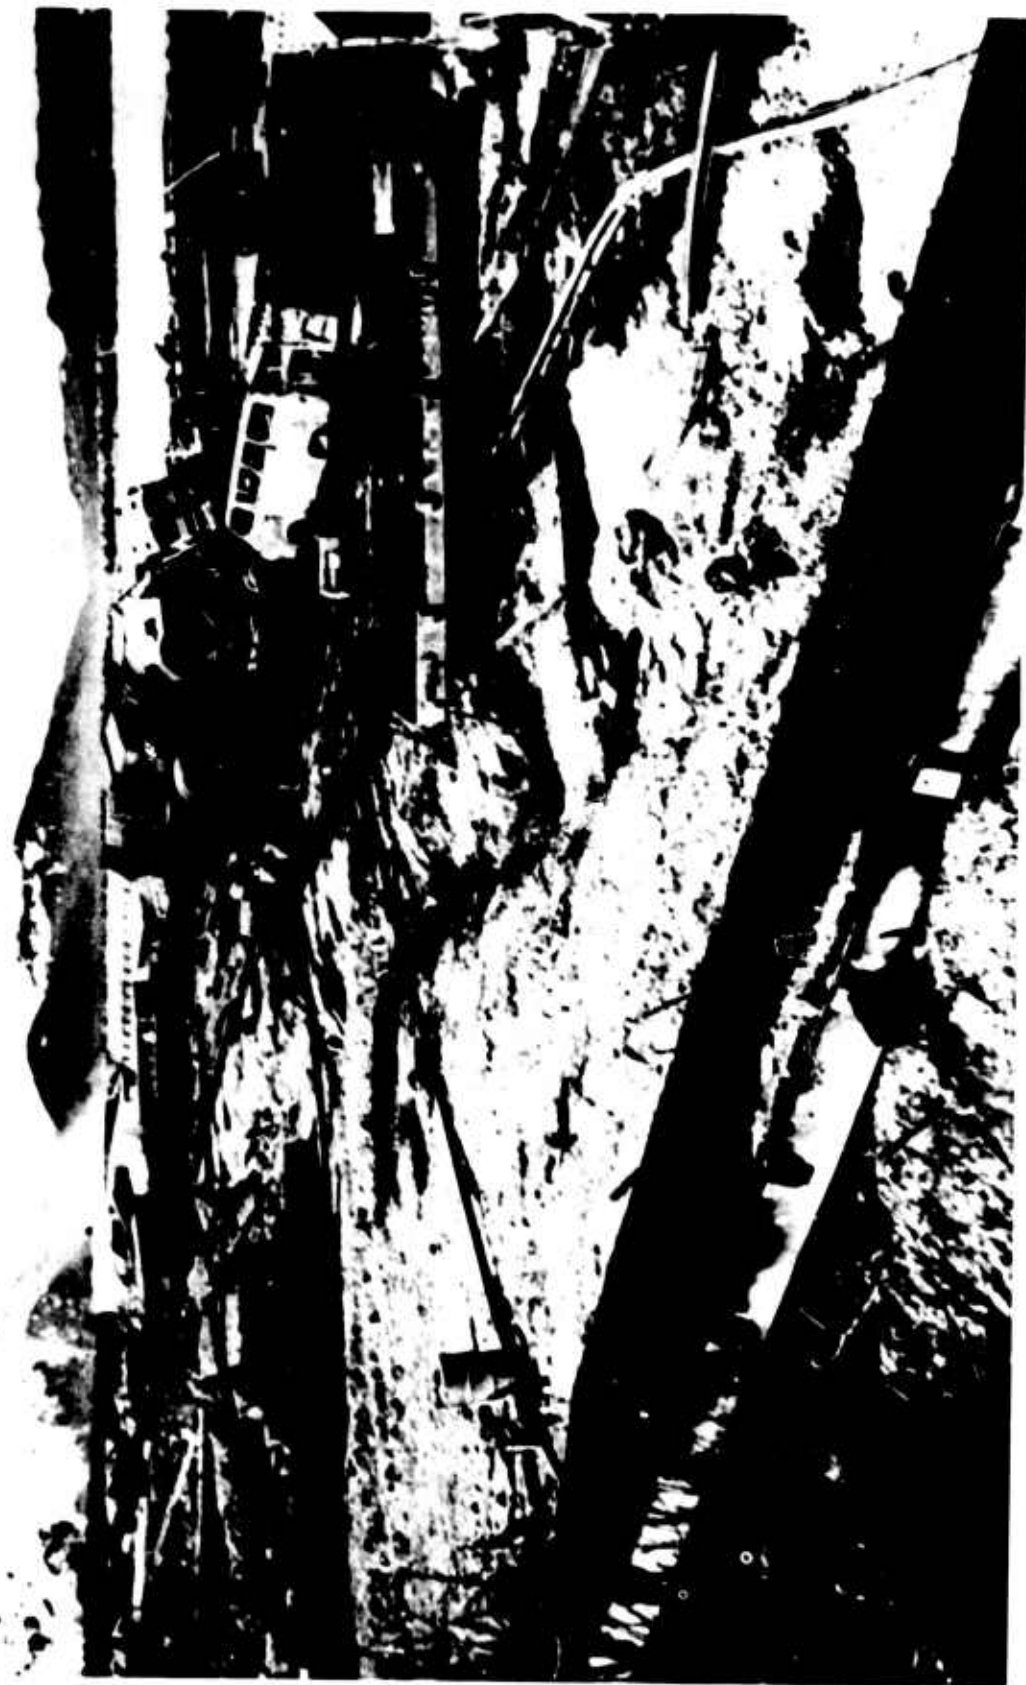
Figure 147 Wave damage in the Alaska Railroad marshalling yard. View looking northeast
(Photograph by U. S. Army)

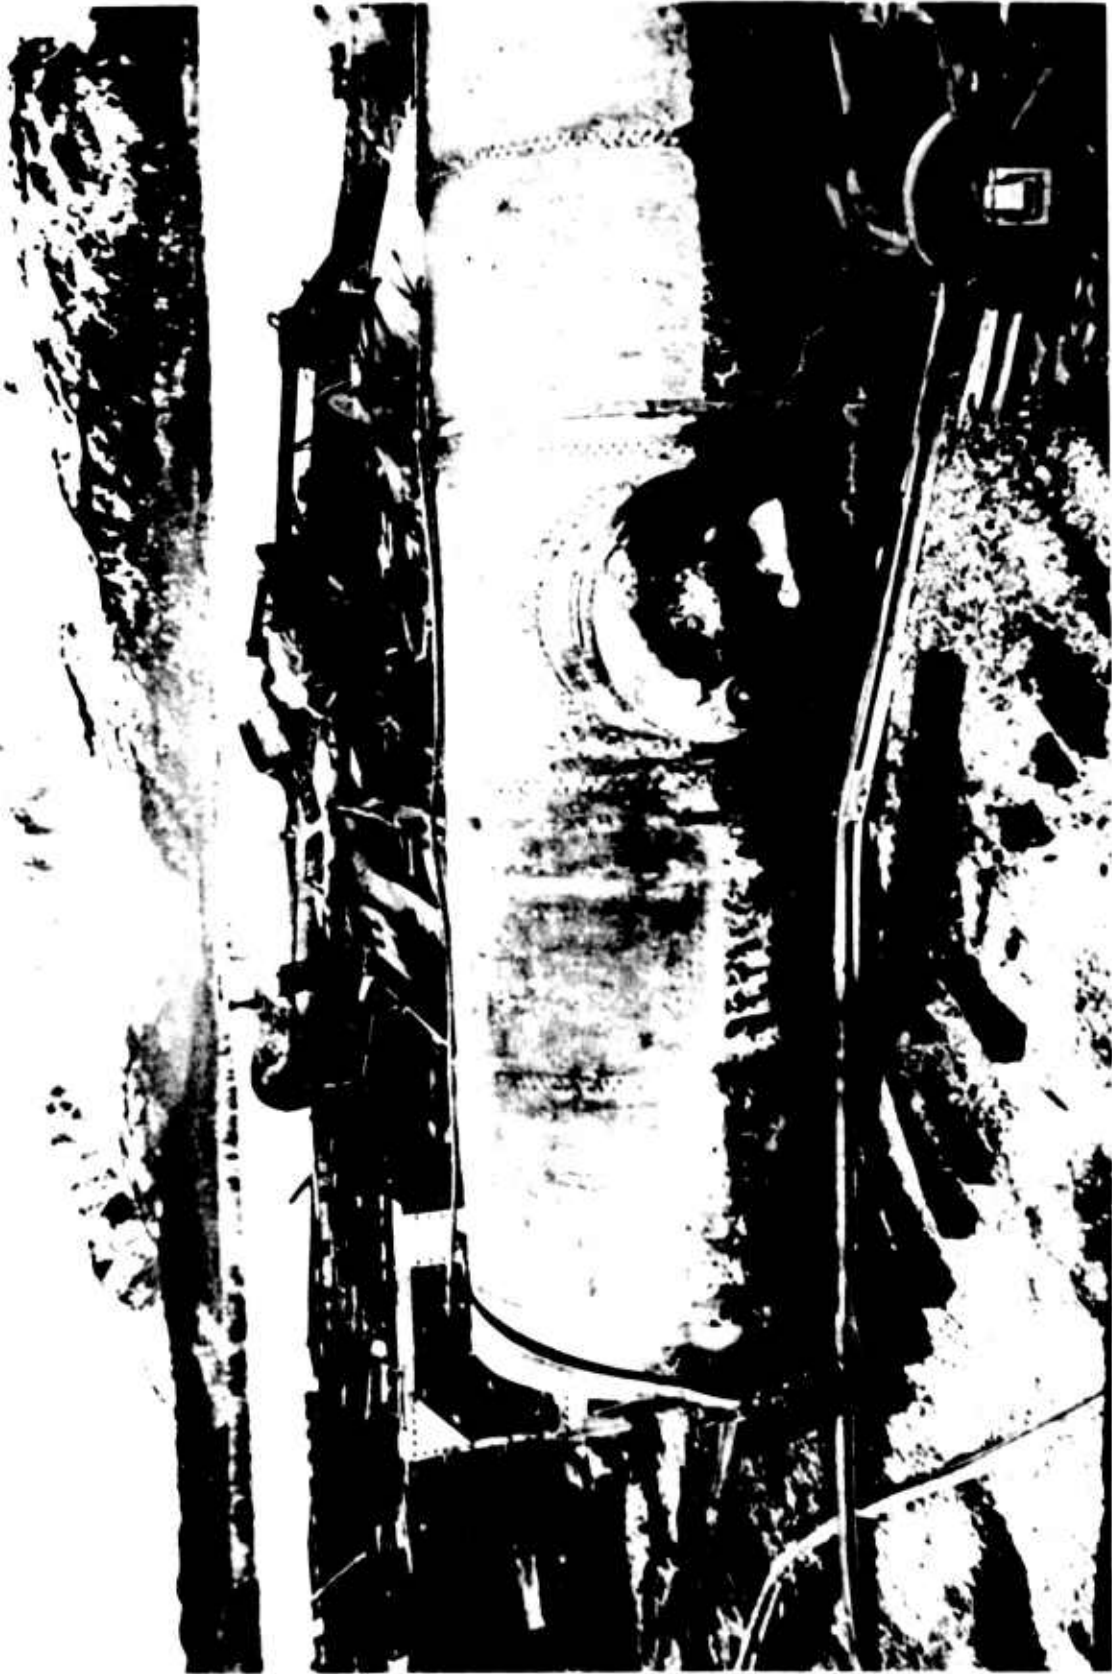
Figure 148 Wave damage in the Alaska Pailroad marshalling yard. (Photograph by U. S. Army)

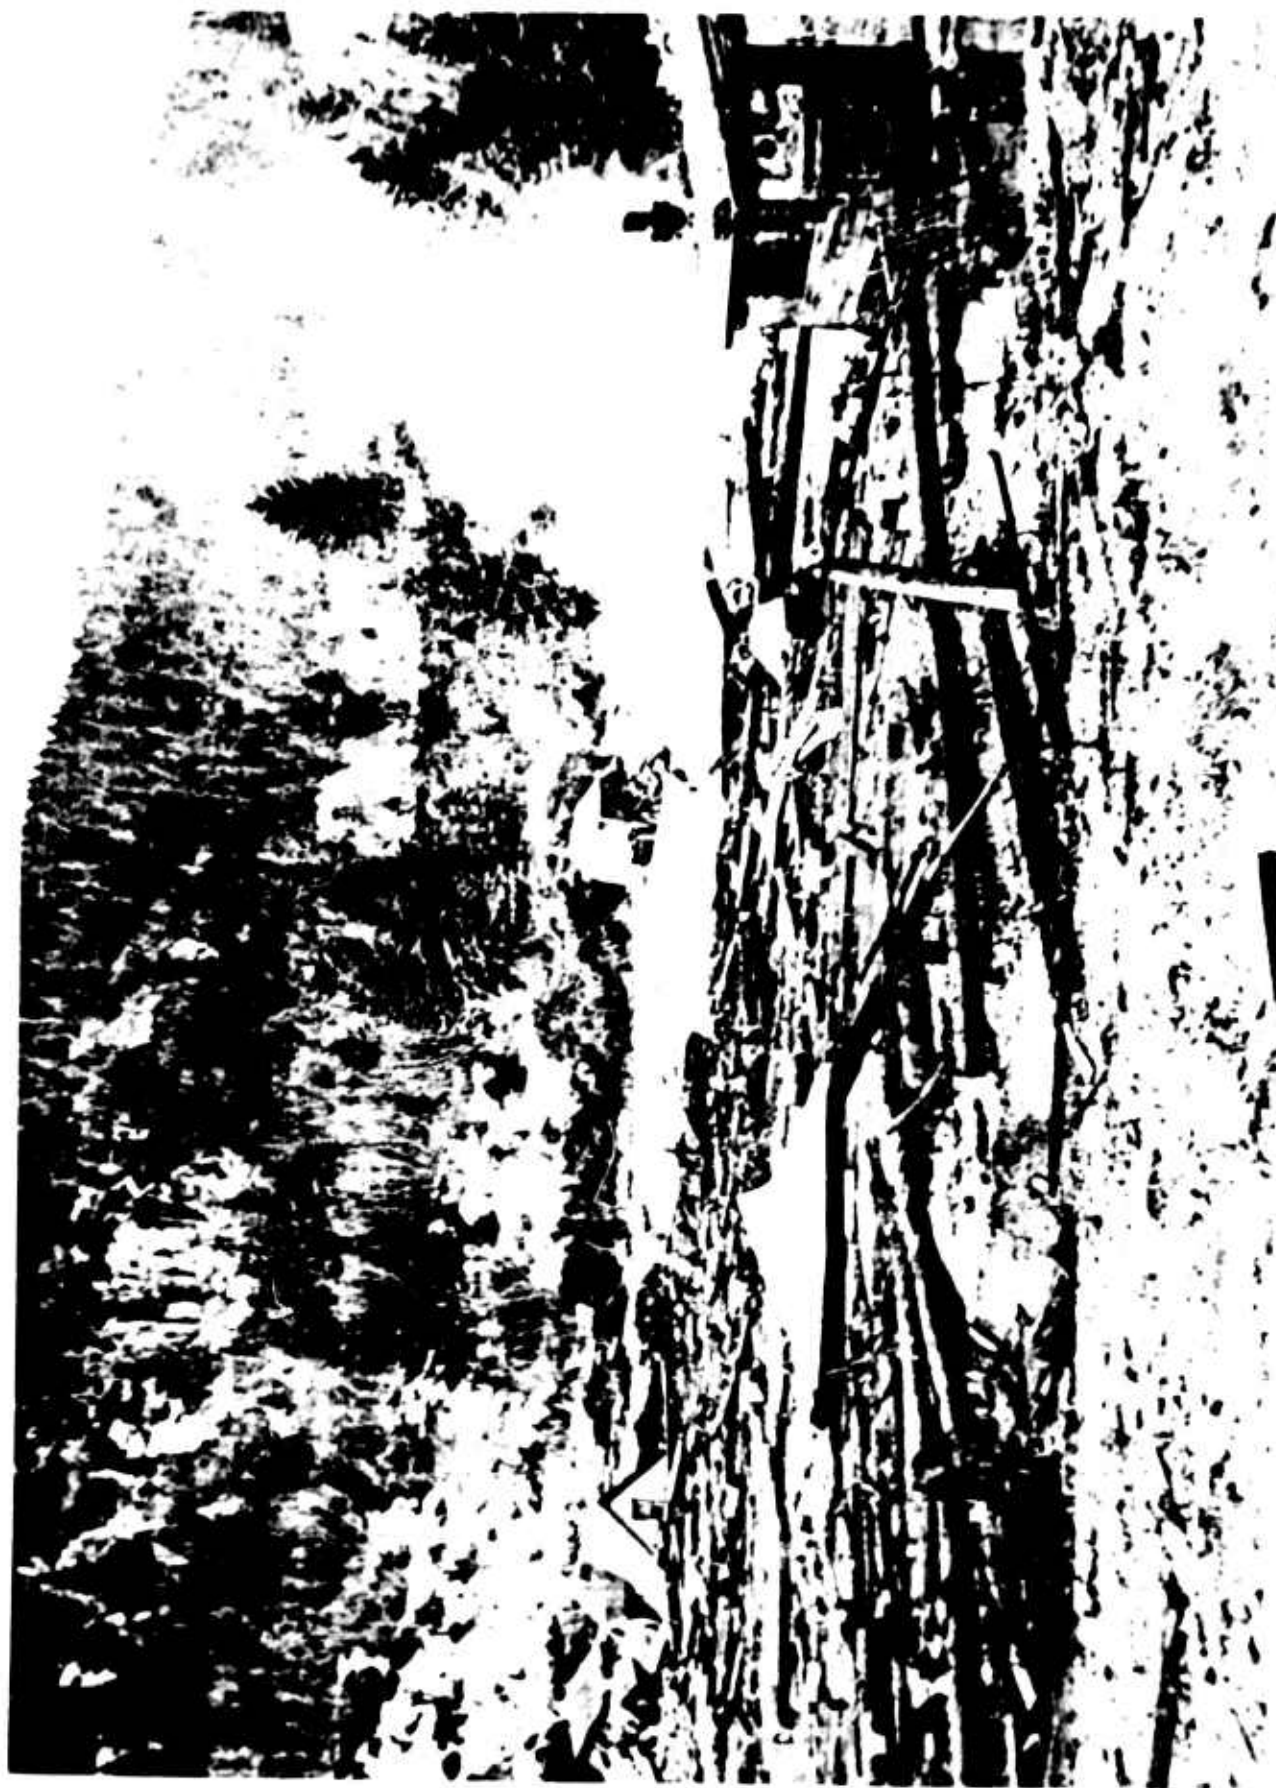
Figure 154 Wreckage of houses and boats carried into the lagoon by the Seismic Sea Waves. Rooftop in center field was the former Seward Radio Station. House at right came from a site near Fourth Street and Van Buren Avenue (see Figure 136).
(Photograph by Dave Thompson, Seward)

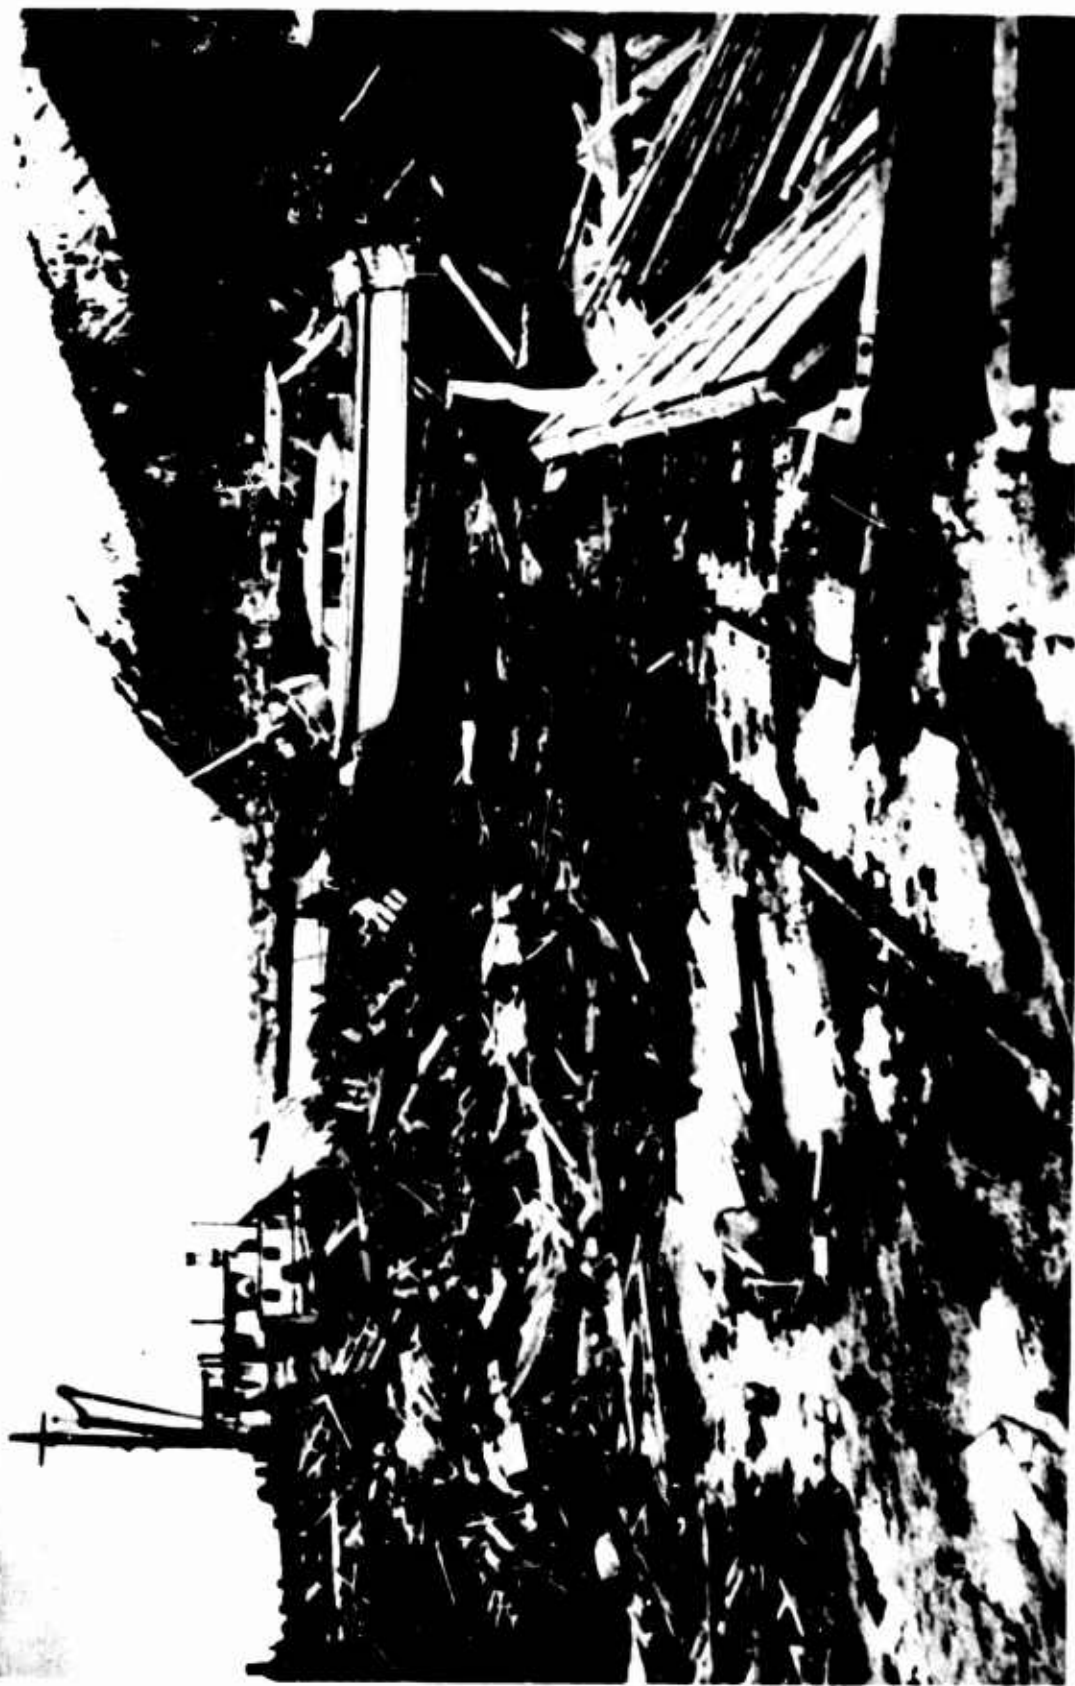
Figure 155 The chaos of wreckage left by the Seismic Sea Waves at the northwest end of the head of Resurrection Bay. View looking south shows Seward in the background. (Photograph by U. S. Army)

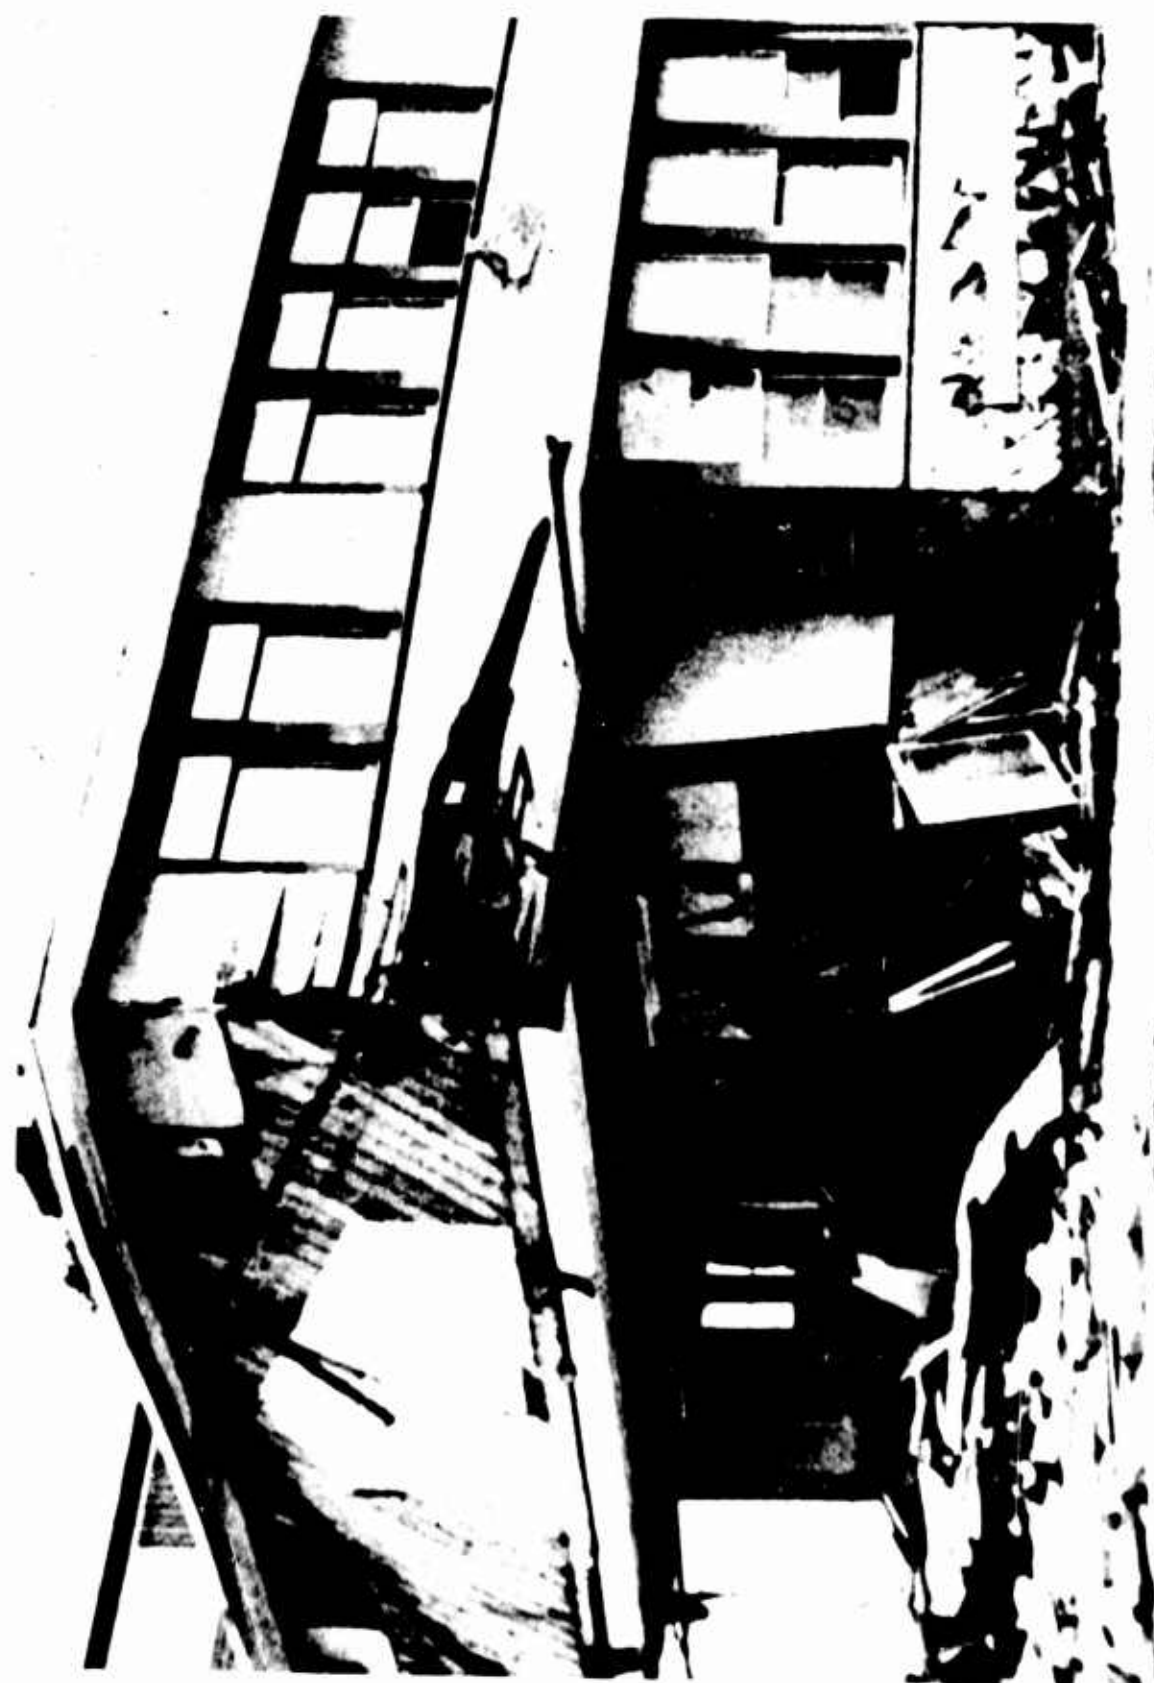
Figure 199 View looking southeast of the Alaska Railroad Depot. The waiting room was destroyed by wave action. (Photograph by Irvin Cook, Alaska Railroad)

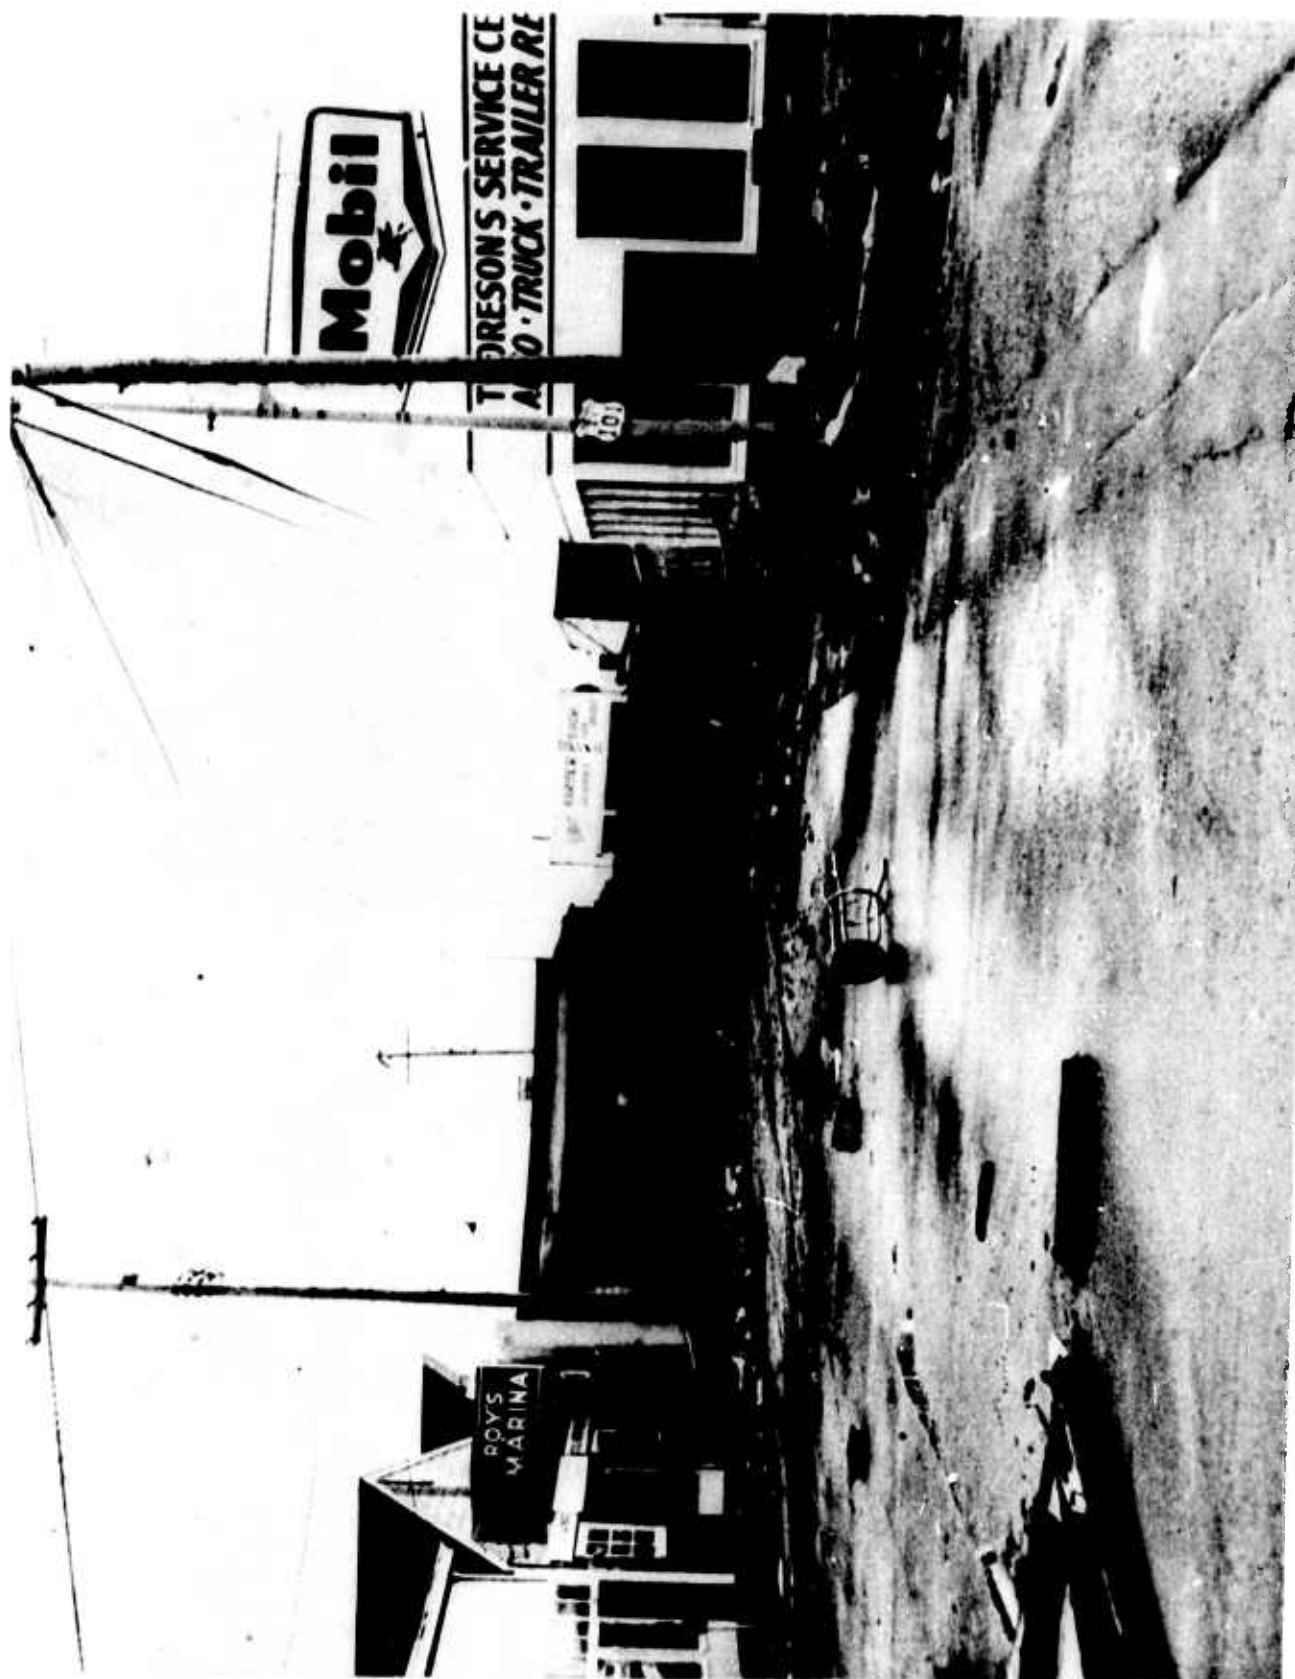
Figure 221 Typical scene of destruction in the downtown area of Crescent City. (Photograph by Harris Studio, Crescent City, California)
